**COMPLIANCE CRASH TESTING OF K-RAIL USED IN
SEMI-PERMANENT INSTALLATIONS**

1. REPORT NO. FHWA/CA/OR-99/07	2. GOVERNMENT ACCESSION NO.	3. RECIPIENT'S CATALOG NO.	
4. TITLE AND SUBTITLE COMPLIANCE CRASH TESTING OF K-RAIL USED IN SEMI-PERMANENT INSTALLATIONS		5. REPORT DATE October 1999

16. ABSTRACT A semi-permanent K-rail barrier was tested in accordance with NCHRP Report 350. The barrier consisted of eight concrete segments 6045 mm in length. The segments were placed on AC pavement and connected with 61.8 x 660 - mm pins. Each segment was then secured to the ground using four 25 x 610-mm steel stakes. The barriers were constructed and tested at the Caltrans Dynamic Test Facility in West Sacramento, California. A total of two crash tests were conducted under Report 350 test level 3, one with an 820 kg sedan, and one with a 2000-kg pickup truck. The results of both tests were within the limits of the Report 350 criteria. It is recommended that the semi-permanent K-rail be approved for use on California State highways where semi-permanent TL-3 barriers are required.

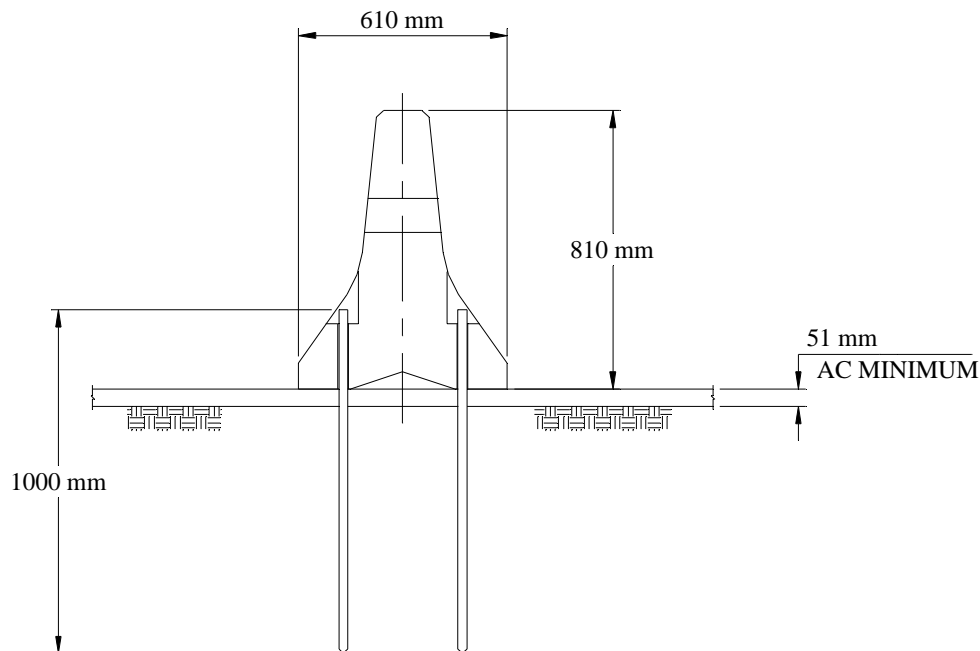
Figure 2-1 - Cross Section of Planned Test Barrier

Refer to Standard Plans July 1997 for
Dimensions, page 132 SECTIONS A-A, B-B.

The final test design consisted of placing eight segments of California K-rail (New Jersey profile) on asphalt concrete (AC) pavement 50-80 mm thick. Each 6.096-m long rail element connected to adjoining elements with 31.8 x 660-mm long pins. Each element was also secured

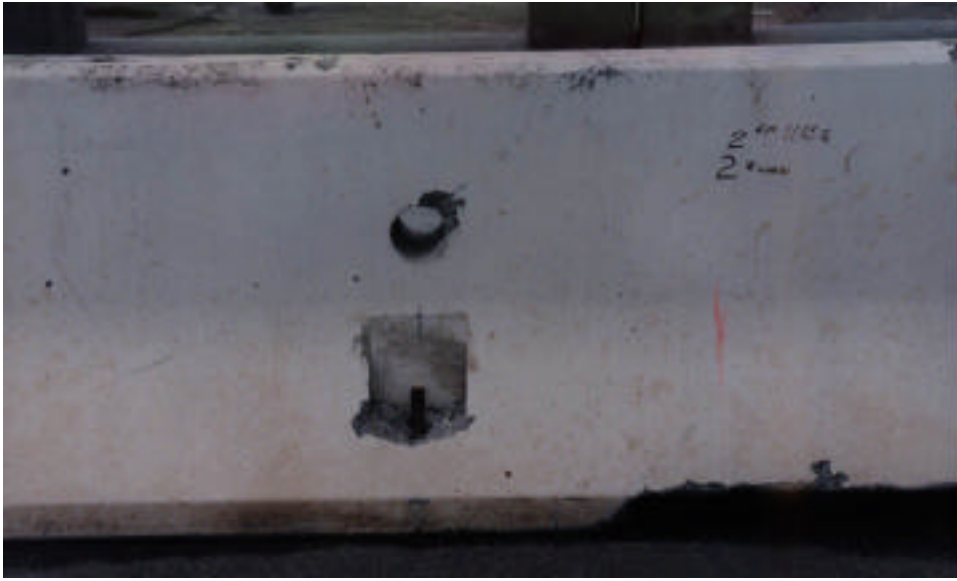
Figure 2-2 - View of
Anchor Stake in
Barrier

Construction of the barrier consisted of obtaining the K-rail, clearing the holes for the stakes, placing and connecting the rail elements, and staking the individual elements to the AC pavement (see Figure 2-2). The final test barrier length was 48.77 m.

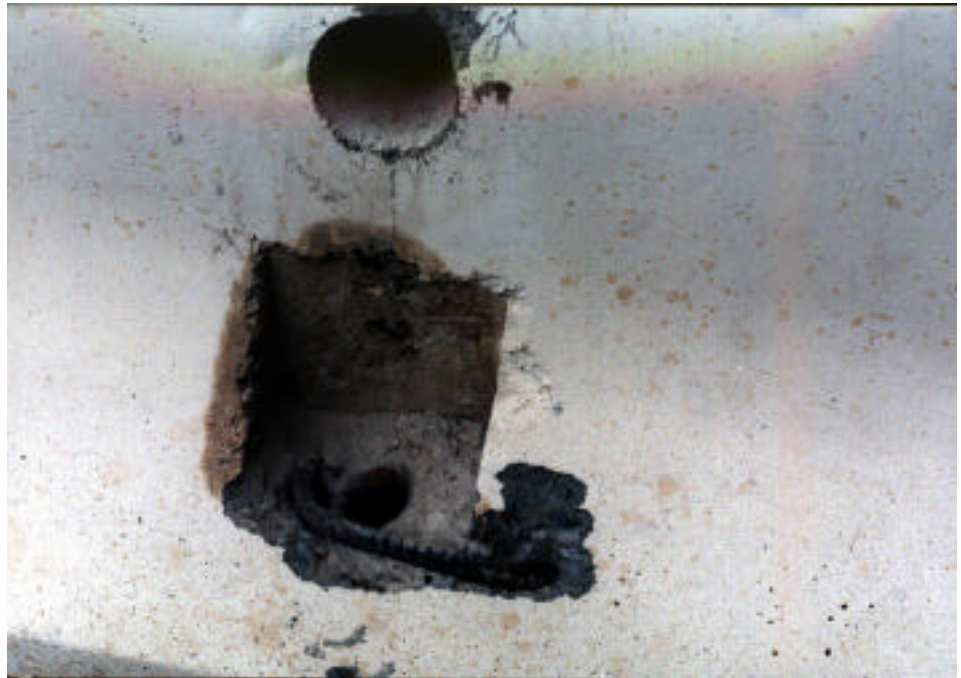
Figure 2-3 - Exposed
Rebar

Because K-rail elements are very common in California, it was decided to order eight used rail elements. The elements were in good condition, except for the stake holes. The quality control of the K-rail elements is clearly a problem. All but two holes had to be cleared of concrete using various methods. Some holes were pounded out with a hammer and chisel. Others were drilled out with a roto-hammer using a 32-mm bit. During some of the stake-hole clearing, the concrete spalled away from the rail element, revealing mislocated reinforcing steel or even the absence of such steel (see Figure 2-3). One hole split completely, eliminating the possibility of getting positive anchoring from the stake.

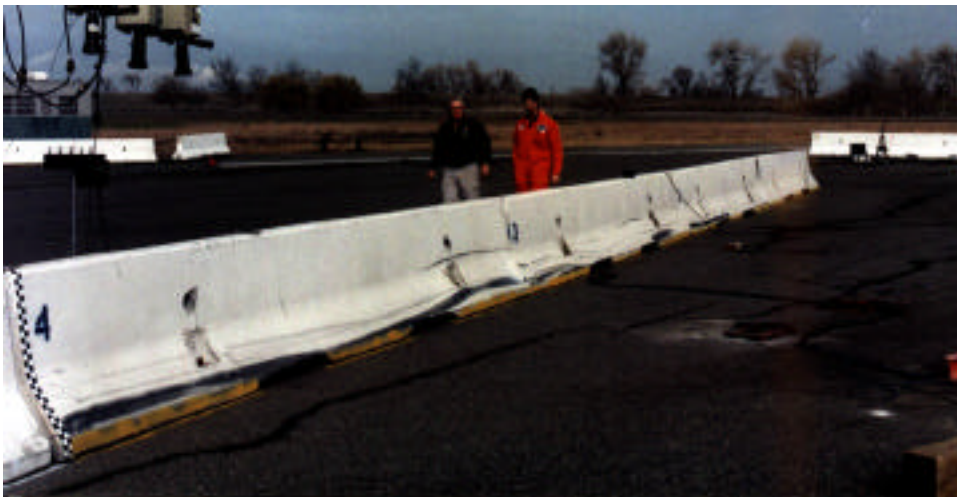
Figure 2-4 -
Assembled Barrier

The barrier was assembled one segment at a time. The elements were placed using a 3600-kg capacity forklift. Pins were placed in the pin-and-loop connections by hand. Those segments that had spalled during the stake-hole clearing were placed at the ends of the test barrier. The barrier was not pulled tight to take up slack in the pin-and-loop connections (see Figure 2-4).

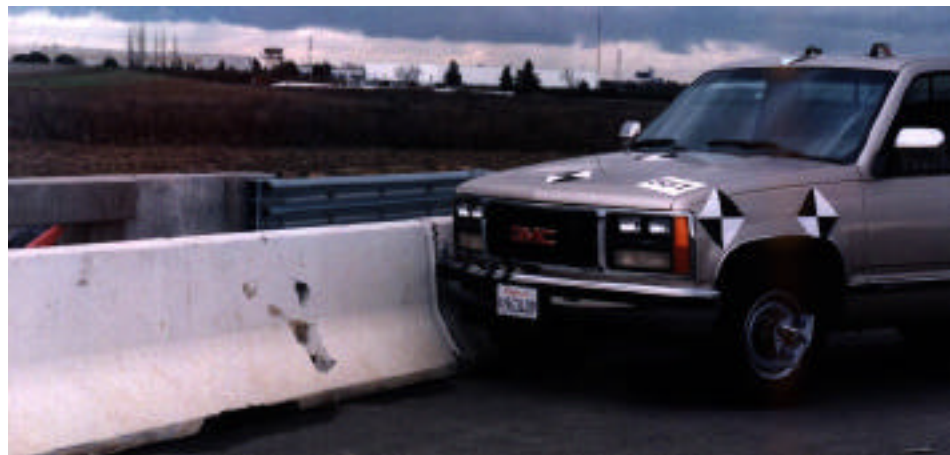
Figure 2-6 - Vehicle 551 At Barrier

The vehicle impact speed and angle were 100.6 km/h and 25 degrees, respectively. Impact occurred at the joint between the forth and fifth segments (see Figure 2-6). As the vehicle hit the barrier, it yawed left until the entire right side of the vehicle was in contact with the face. At 0.2 seconds the vehicle started to ride upward. All four wheels lost contact with the ground as the front bumper reached the next segment (about 6 m downstream). The vehicle touched down 12 m further downstream. As the front left tire hit the ground, the roll and pitch were measured to be 12.8° and 25°, respectfully. The vehicle immediately started to right itself and was stable about 4 meters past the end of the barrier (about 16 m downstream of the point of impact). The exit speed and angle were 82 km/h and 6 degrees respectively. The 6-degree exit angle is well within the 60% limit of Report 350.

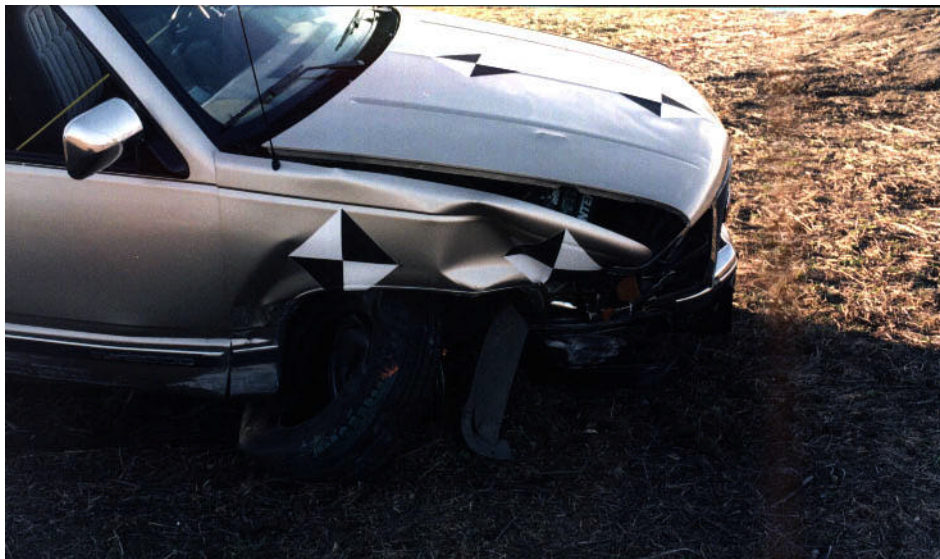
Figure 2-10 - Front
Impact Side of
Vehicle

Most of the damage to the vehicle was confined to right front corner. The right front tire was separated from the wheel. The right front fender and bumper were crushed (Figure 2-10). The tie-rod was broken, but the left front wheel could still be controlled by the steering wheel. There were scuff marks and scratches along the entire right side of the vehicle. The left rear wheel sustained minor damage, but the tire was still inflated.

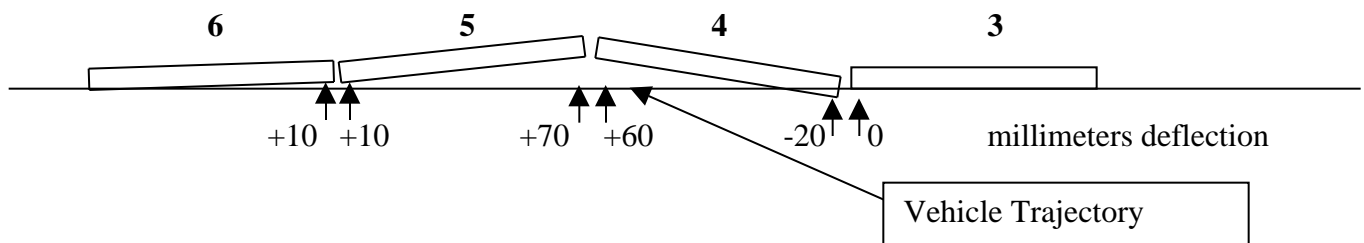
The barrier underwent some permanent deflection:

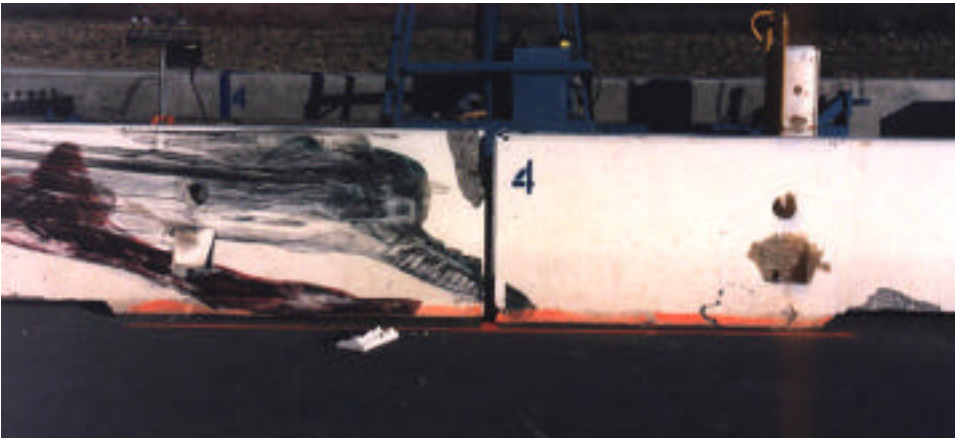
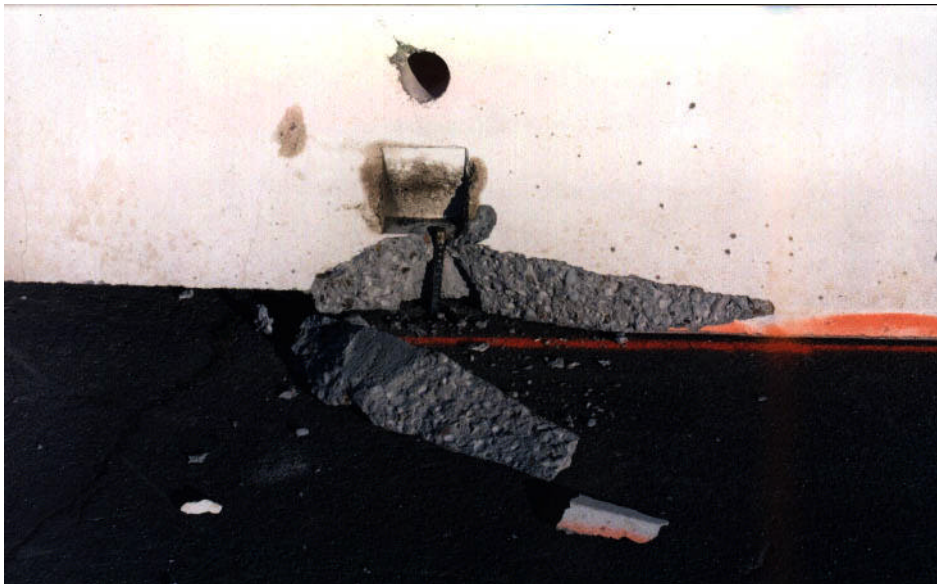
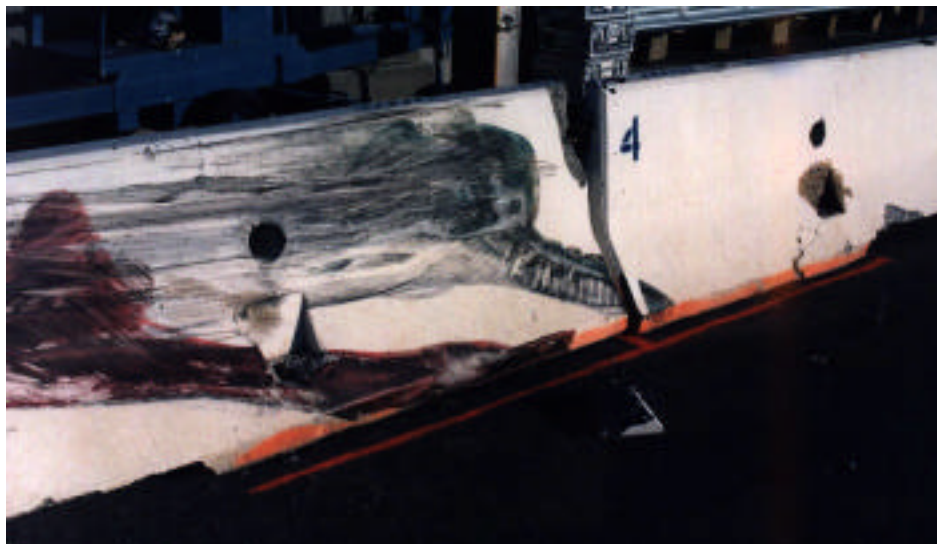
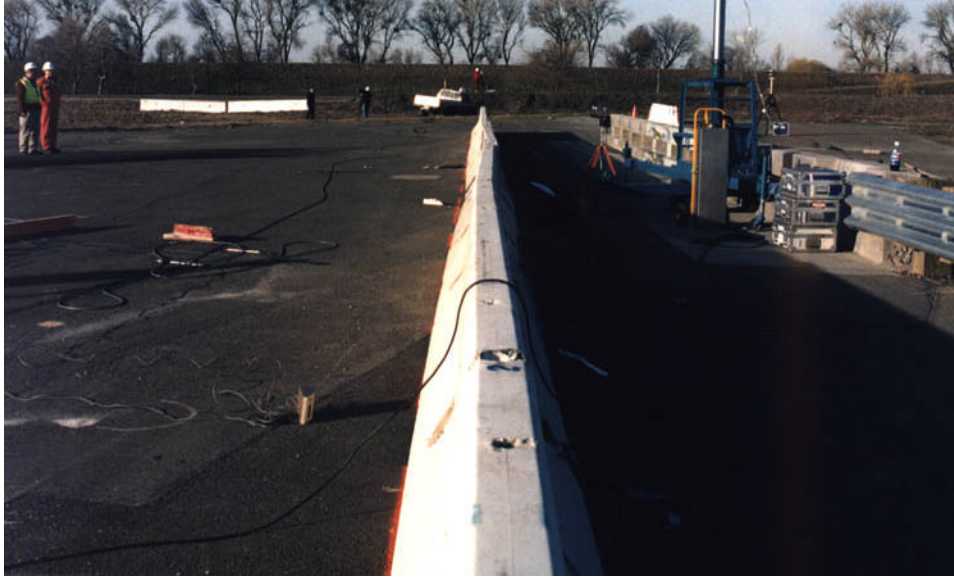
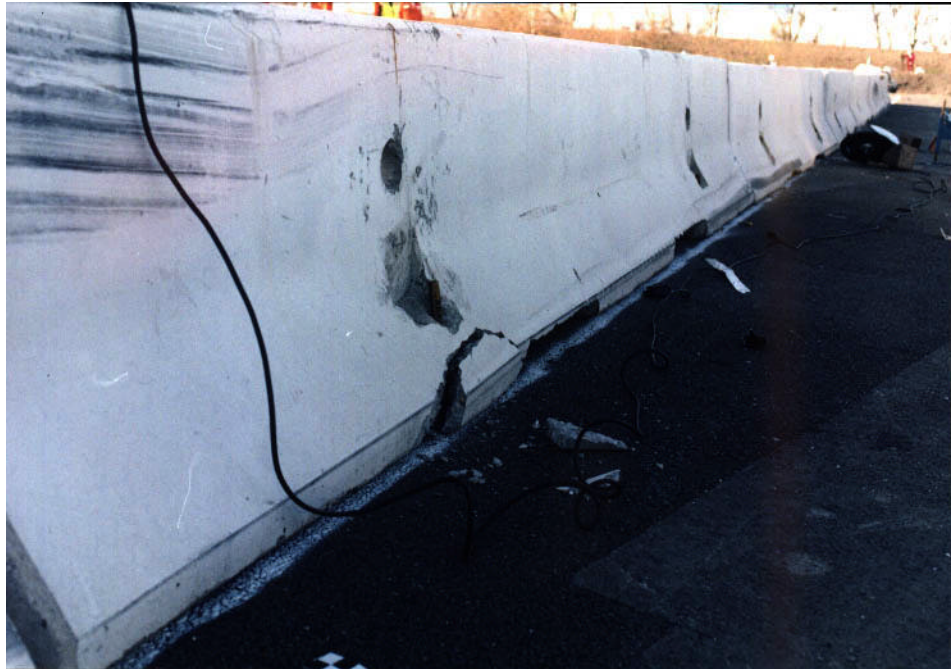
Damage to the barrier was minimal (Figure 2-11 through Figure 2-15). The connecting pin-and-loop at joint 4-5 bent enough that it caused minor spalling and the pin had to be cut before the barrier could be moved. The maximum lateral displacement measured at the top of the barrier was 260 mm during impact. There was also some minor spalling of anchor stakes in segments 4 and 6.

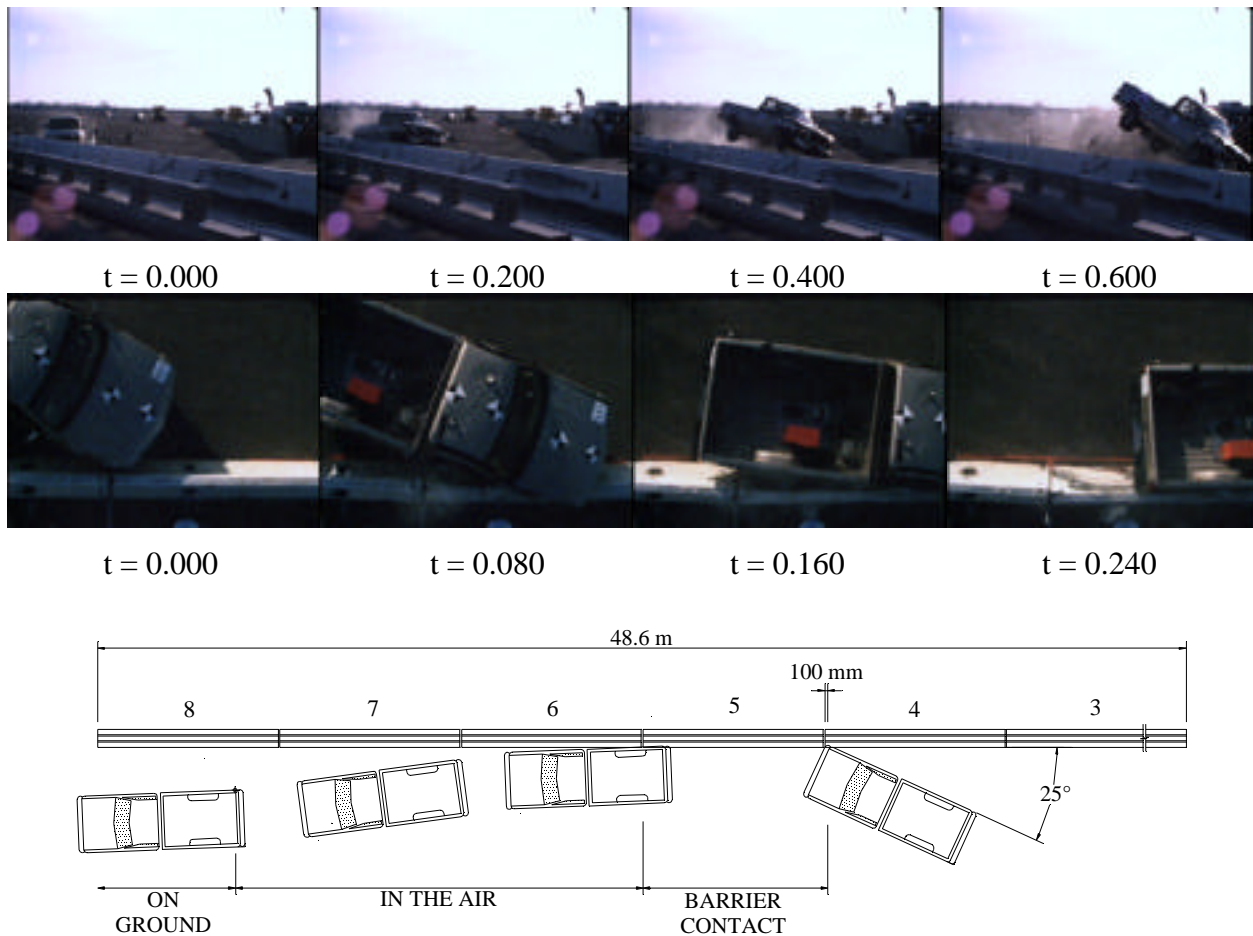
Figure 2-16 - Test 551 Data Summary Sheet

Barrier Damage: Spalling at the pin-and-loop
 connection at point of
 impact, also at some of the
 anchor stakes. Superficial
 scuffing

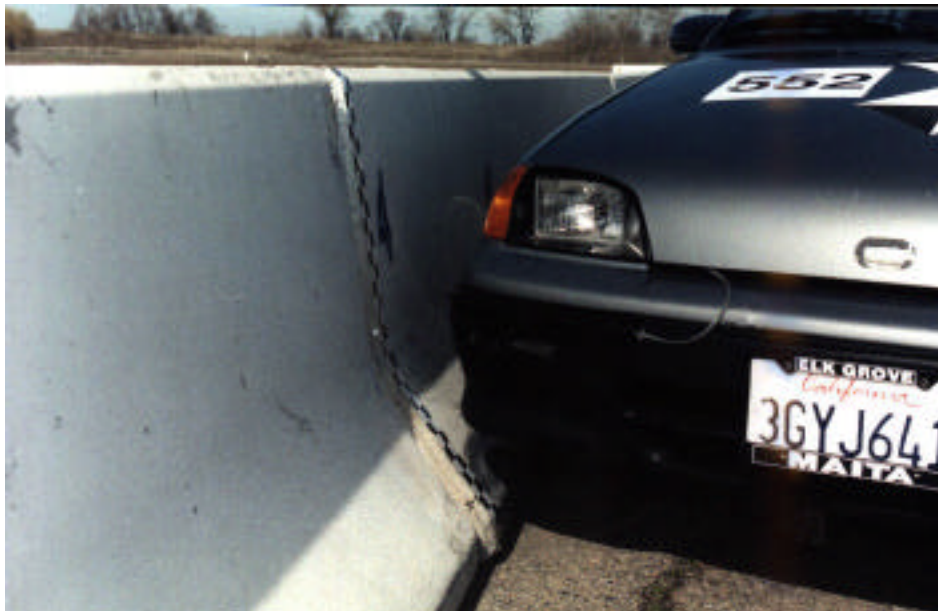
Figure 2-17 - Vehicle 552 At Impact Point

The vehicle impact speed and angle were 101.7 km/h and 20 degrees, respectively. Impact occurred at the joint between the forth and fifth segments (see Figure 2-17). Within the first 3 m of barrier contact, the vehicle rotated 20 degrees to the left, the rear hatch opened up and all four wheels left the ground. Contact with the barrier continued for about 8 m while the vehicle rose. The vehicle stayed level while rising to an ultimate height of 630 mm. The vehicle came back down 15 m downstream of the impact point (see Figure 2-21 through Figure 2-23).

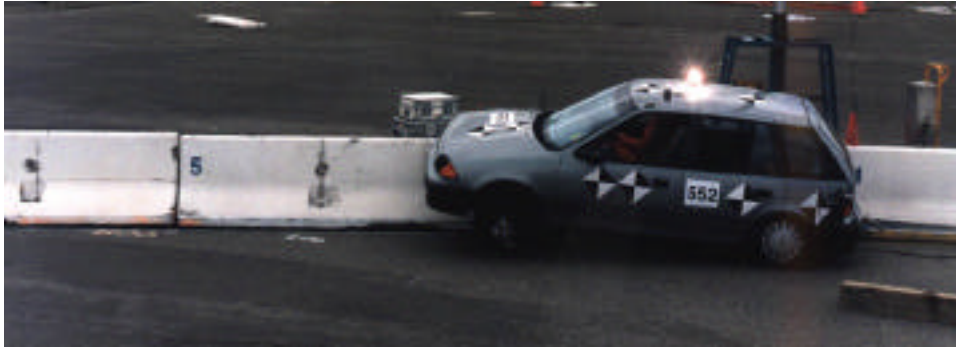
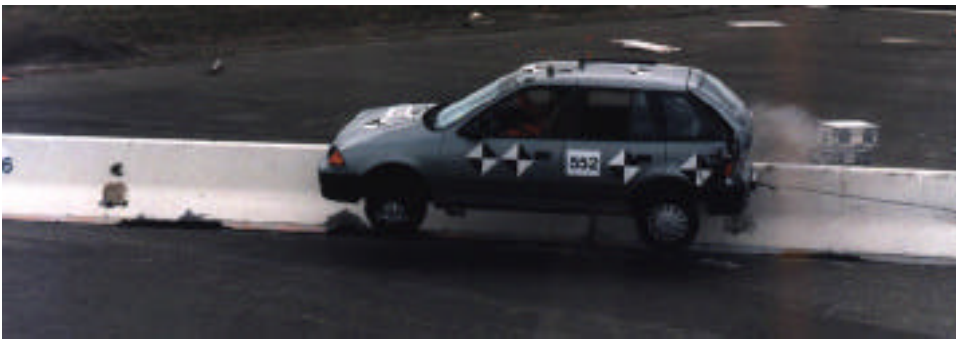
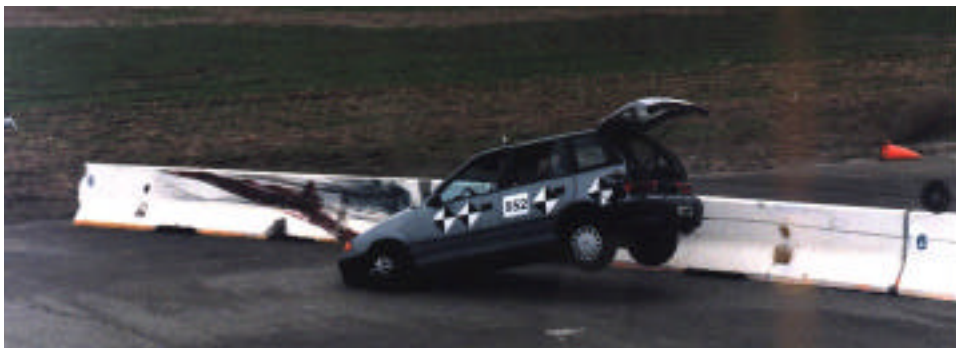
The exit speed and angle were 97 km/h and 4 degrees respectively. This exit angle is well within the limit of 60% of the impact angle, as specified by Report 350. The vehicle stayed upright and tracked smoothly until coming to rest approximately 67 m downstream.

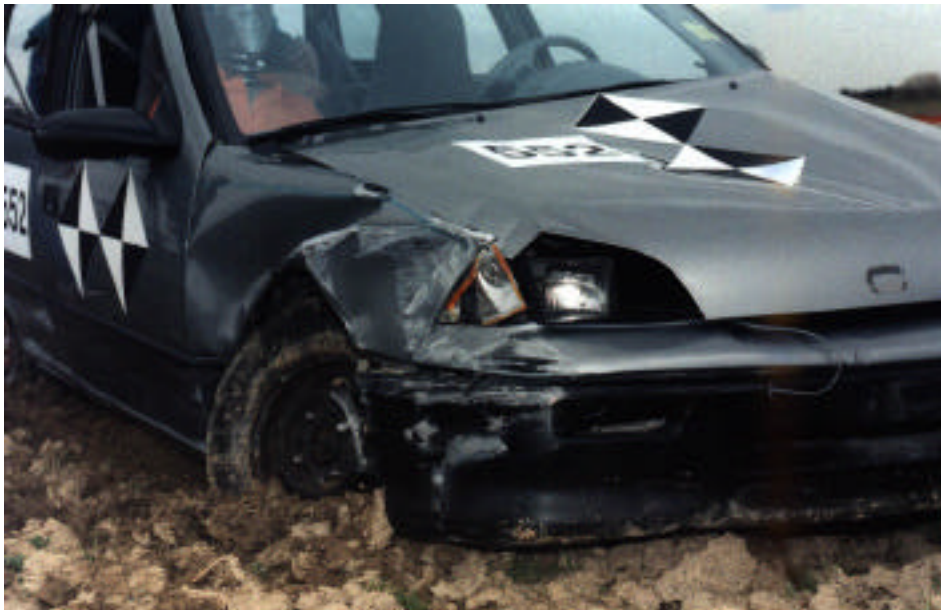
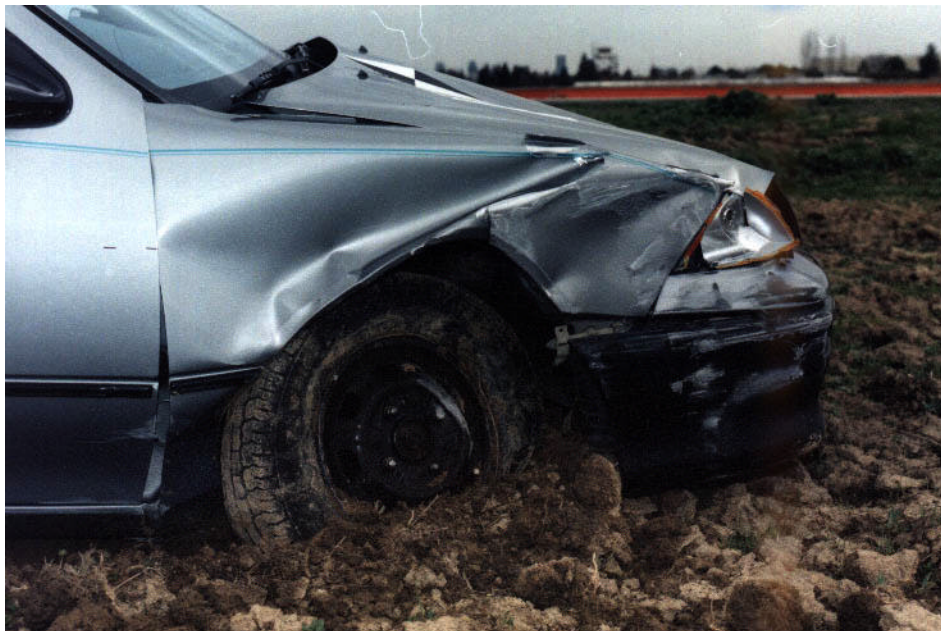
As in Test 551, most of the damage to the vehicle was confined to the right front corner. The right 300 mm of the bumper was slightly pushed into the fender panel and the fender had considerable sheet metal damage. The parking light was broken. The right wheel assembly was pushed back and to the left, with the bottom of the wheel canted outward (see Figure 2-24 and Figure 2-25).

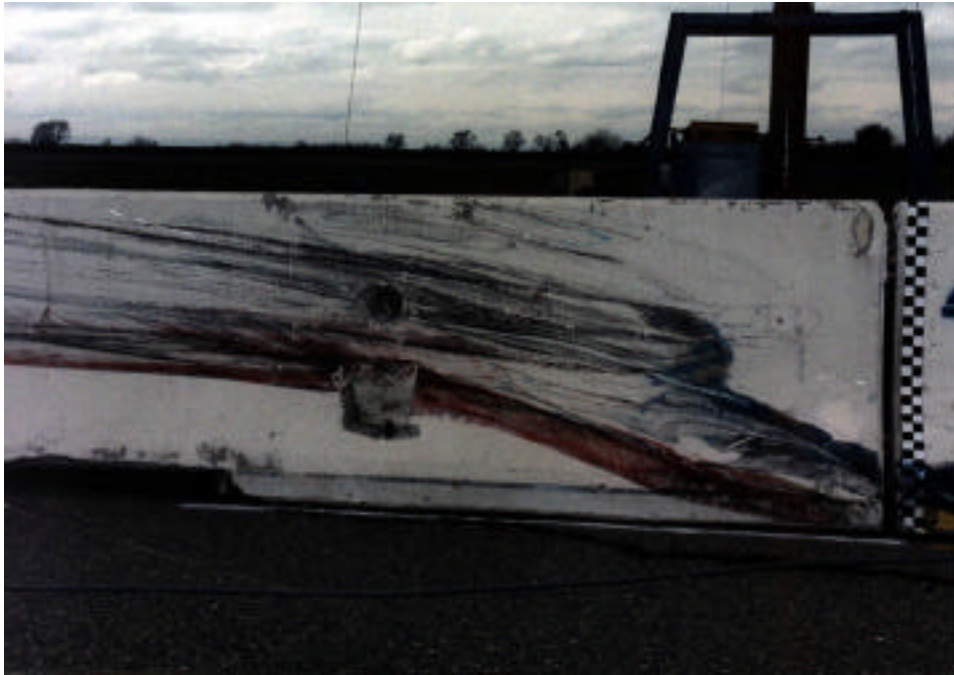
Figure 2-26 - Test
552 Barrier
Scuffing

Damage occurred only on the front of the barrier. Vehicle contact was limited to segments 4 and 5, where the barrier received superficial scuffing (see Figure 2-27). The K-rail cracked around several of the stake holes, but they all retained their integrity. The barrier rotated back approximately 30 mm during impact, but righted itself as the vehicle lost contact with the barrier.

Segment 4 had a permanent deformation of 25 mm, with the front edge of the barrier raised about 10 mm. The loop connections did not incur any damage.

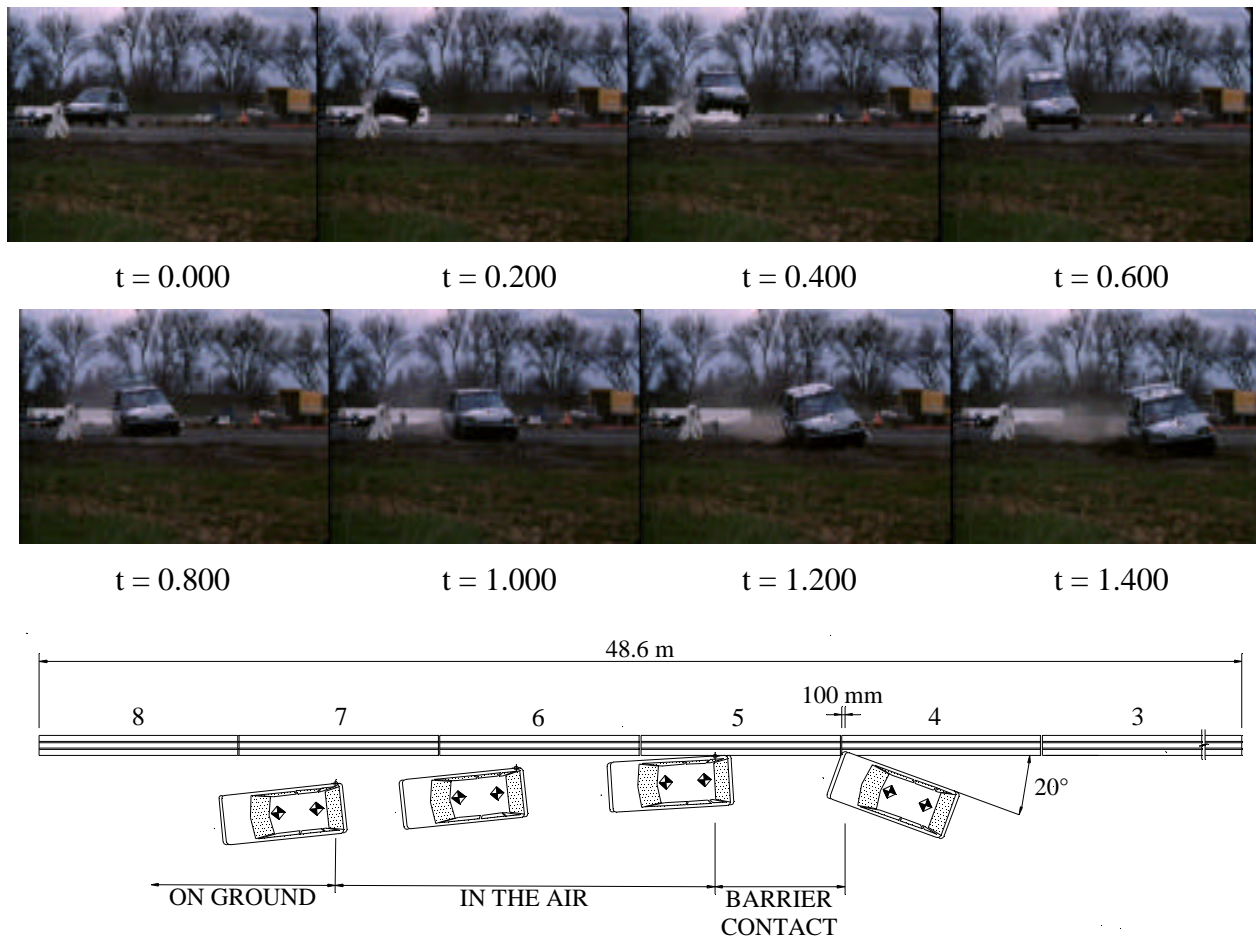
Figure 2-27 - Test 552 Data Summary Sheet

Barrier Damage: Superficial scuffing.

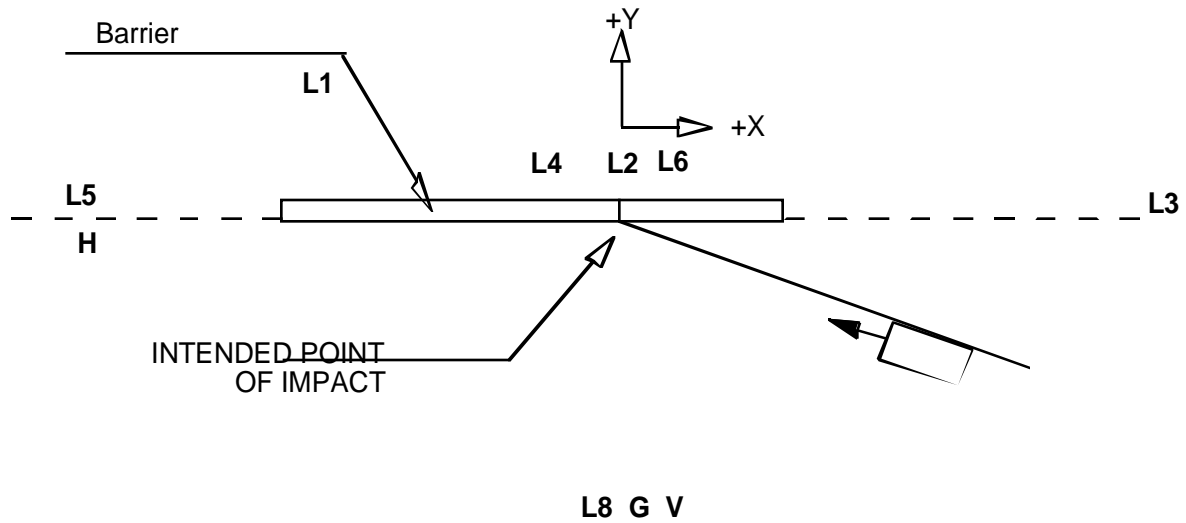
Figure 6-1 - Camera Locations

All of these cameras were mounted on tripods except the three that were mounted on a 10.7 m-high tower directly over the impact point on the test barrier.

A video camera and a 16-mm film camera were turned on by hand and used for panning during the test. Switches on a console trailer near the impact area remotely triggered all other cameras. Both the vehicle and barrier were photographed before and after impact with a normal-speed movie camera, a beta video camera and a color still camera. A film report of this project has been assembled using edited portions of the crash testing coverage.

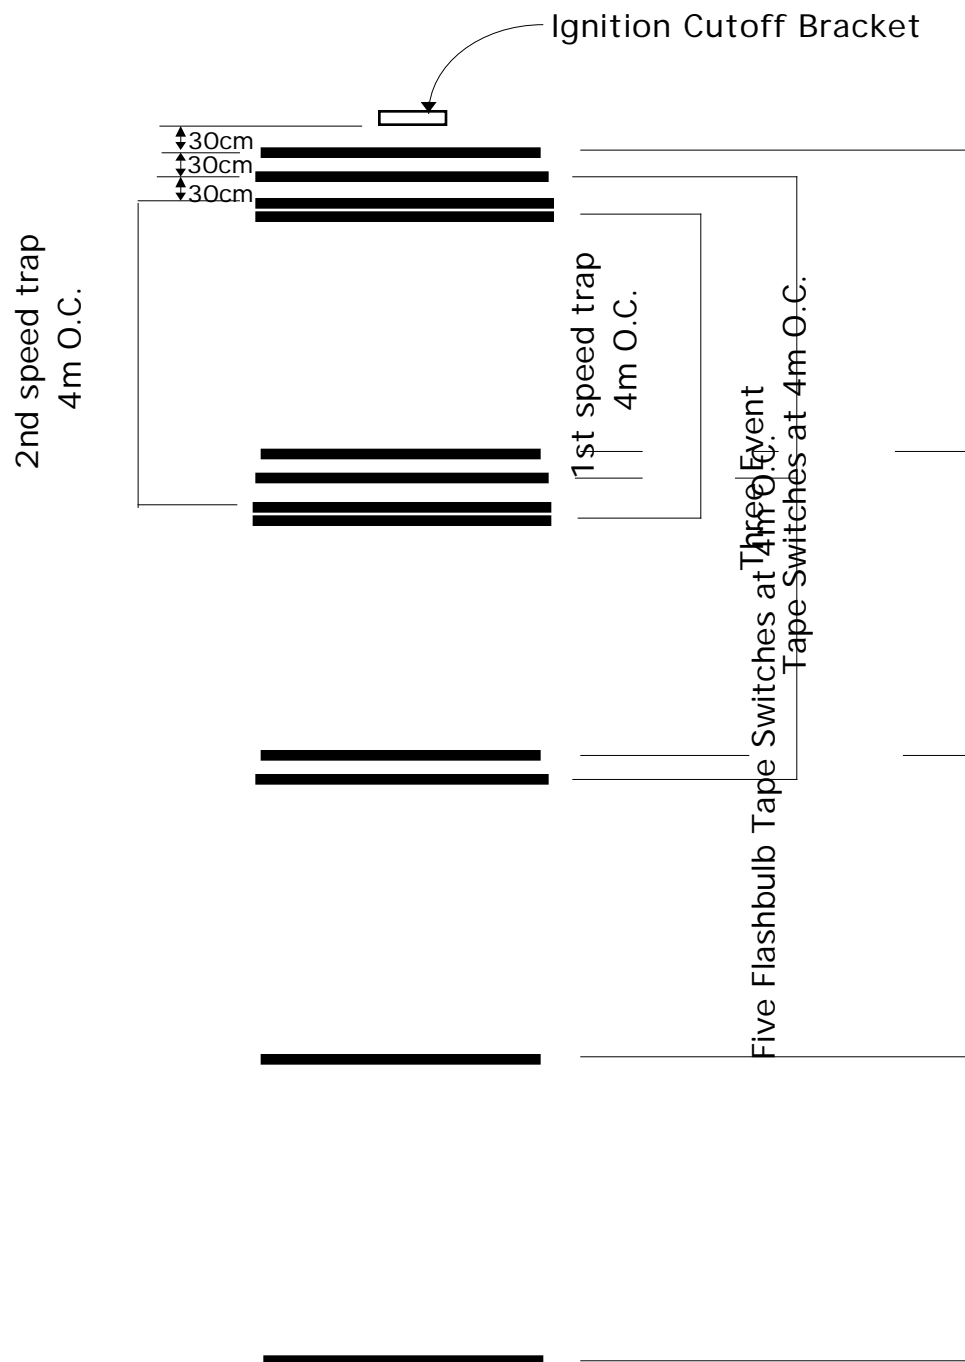
Figure 6-2 - Tape Switch Layout

3) Five tape switches, placed at 4-m intervals, were attached to the ground near the barrier and were perpendicular to the path of the test vehicle. Flash bulbs were activated sequentially when the tires of the test vehicle rolled over the tape switches. The flashbulb stand was placed in view of most of the cameras. The flashing bulbs were used to correlate the cameras with the impact events and to calculate the impact speed independent of the electronic speed trap. The tape switch layout is shown in Figure 6-2.
